**DEPARTMENT OF TRANSPORTATION**

Contract #: 04-0120F4Cty: SF/ALA Rte: 80 PM: 13.2/13.9File #: 74.28**WELDING INSPECTION REPORT****Resident Engineer:**Siegenthaler, Peter**Address:** 333 Burma Road**City:** Oakland, CA 94607**Report No:** WIR-022652**Date Inspected:** 31-Mar-2011**Project Name:** SAS Superstructure**OSM Arrival Time:** 800**Prime Contractor:** American Bridge/Fluor Enterprises, a JV**OSM Departure Time:** 1730**Contractor:** Goodwin Steel, UK**Location:** Trentham, UK

# WELDING INSPECTION REPORT

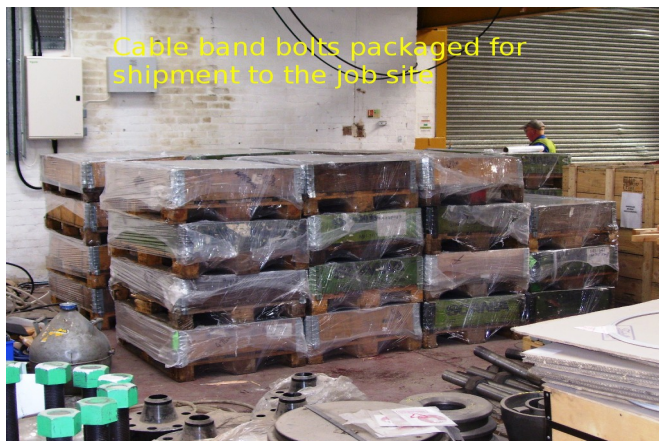
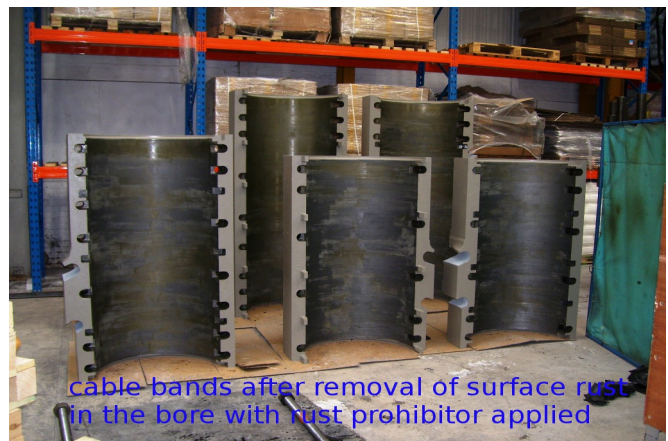
a. West Panel Point 26. The record of post weld heat treatment for repair R3 is not included in the partial documentation package. Mr. C. Ryder has been made aware of this.

b. East Panel Point 28. RFI 2091 applies to this cable band

A Green tag with blue dot with lot number B248-085-11 was assigned for the cable band for West Panel Point 26 and for the cable band for East Panel Point 28.
